Building America Case Study Technology Solutions for New & Existing Homes

Measure: Complete and Fully Aligned Air Barrier

Portland, Oregon

Bryce Deep Energy Retrofit

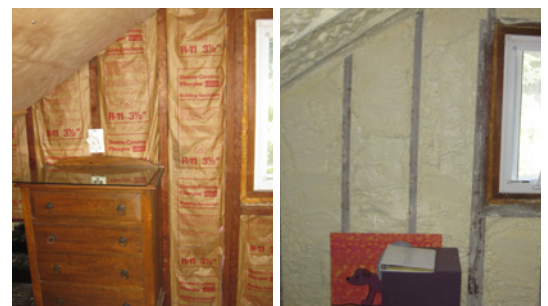
The side attics had a mixture of insulation types, including faced and unfaced fiberglass batt insulation (*left*). These were replaced with closed-cell spray foam on the exterior walls and roof deck to provide a complete and continuous air barrier (*right*), fully aligned with the vapor barrier. This reduced infiltration, mitigating the stack effect, which was pulling warm, moist air up into the attic.

To alleviate these issues, the homeowners worked with the Building America team to provide a complete, continuous air barrier that is fully aligned with the existing thermal and vapor barriers (in this case, the spray foam serves as both) by applying R-30 spray foam to the roof deck and exterior walls in the side attics. Before renovation, the relative humidity in the attic was approximately 60%, about 20% greater than the average interior relative humidity levels in this house. After the retrofit, the home has felt much cooler and less stuffy, according to the homeowner. The building air leakage also decreased from 6.6 air changes per hour at 50 pascals of depressurization (ACH50) to 4.3 ACH50, which is below the minimum ventilation limit for this home. Thus, in addition to air sealing, vents were added between the top attic and the second floor to increase air exchange and further prevent condensation, and a heat recovery ventilator (HRV) was added to provide adequate ventilation in the home. This additional ventilation, combined with a complete and fully aligned air barrier, helped solve this home's moisture problems while making the home much more efficient and comfortable.

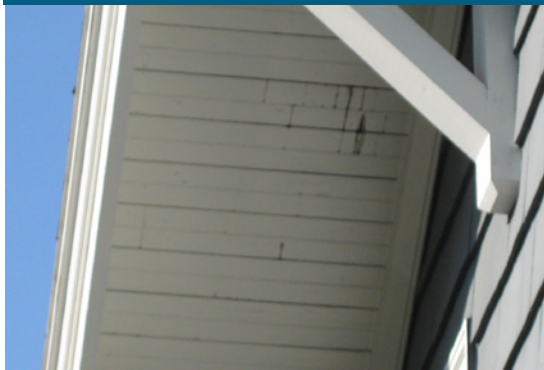
(top) Excessive humidity and condensation in the attic was causing unsightly staining and damage in the side attic spaces and on the eaves.

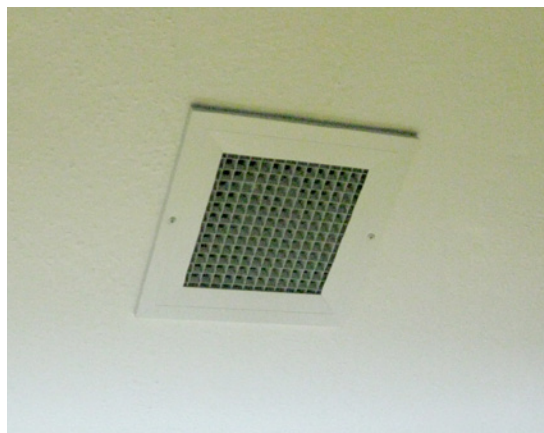
(bottom) The spray foam insulation in the top attic was trapping interior, warm air and moisture, significantly increasing the relative humidity levels. To relieve the excessive moisture build up and increase comfort on the second floor, passive transfer grilles were added between the second floor and the attic to increase air exchange between conditioned spaces, and an HRV was installed to increase overall ventilation in the home.
