Safe and Effective Exterior Insulation Retrofits: Phase II

by Colin Craven and Robbin Garber-Slaght
January 15, 2012

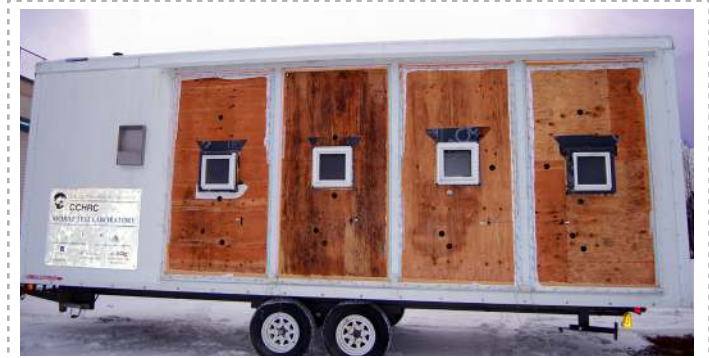
Exterior of the Mobile Test Lab at the end of the 2-year study, with the siding and insulation removed.

In the summer of 2011, the MTL test walls were disassembled and inspected. Some of the test walls had varying degrees of mold and water damage on the wood components. Note that rot would take longer to develop, so the observations summarized here are limited to measured data and visible mold. CCHRC found that the monitoring and inspection results can be largely explained based on the presence or absence of an interior vapor retarder and the distribution of interior-to-exterior insulation.

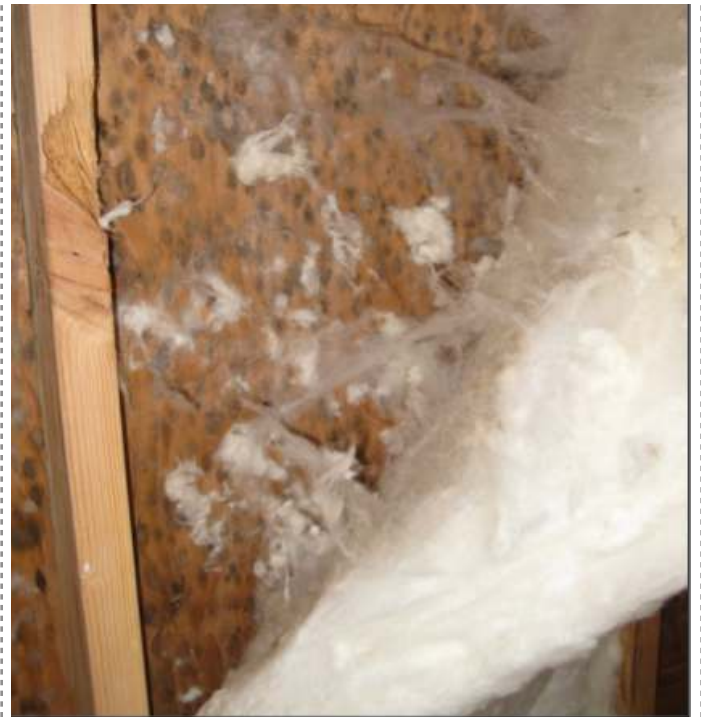
In contrast, the test wall with thin exterior insulation (the red line) remained below the dew point for almost all of the first winter and most of the second winter. Correspondingly, this test wall had abundant mold after the two-year experiment. The test wall with no exterior insulation (the blue line) had the coldest sheathing. In fact, sheathing on this test wall was below freezing for almost the entire winter. Interestingly, this test wall had only small areas of visible mold, so colder sheathing and dew point analysis alone is not sufficient to explain our observations. One explanation is that the continuous subfreezing temperatures inhibited the ability of mold to grow. Also, the

Figure 2. Mold on the sheathing behind the fiberglass on a wall with thin exterior insulation.

Based on the MTL experiments and WUFI® simulations, retrofitting walls with foam insulation is safest when 65% or more of the total wall R-value is exterior to the sheathing. However, the “double vapor barrier” effect only seems to be a concern for wall systems with approximately 30% or less of their R-value exterior to the sheathing coupled with relatively high interior humidity. While only one of the test walls fit that description, it is common for residential retrofits to have less than 30% of the wall’s R-value exterior to the sheathing. In such cases, the

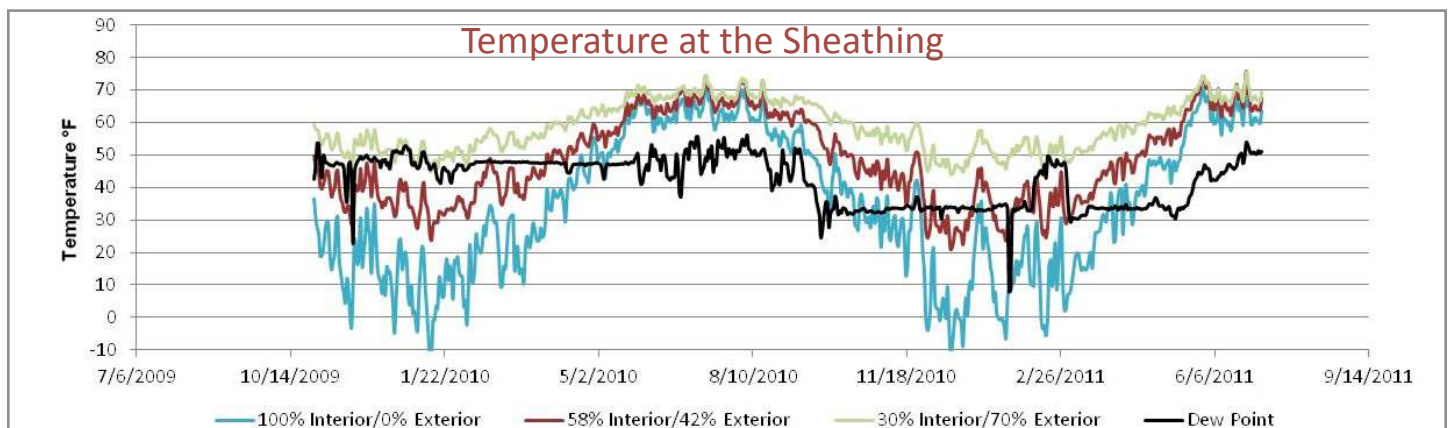
Insufficient exterior insulation means that the sheathing can become colder than the dew point in winter, allowing water vapor to condense on the inside sheathing surface (see sidebar, Dew Point and Humidity). If this occurs frequently, it can lead to mold growth and eventually rot. Ideally, the wall will have sufficient exterior insulation so that the sheathing remains above the dew point. This is illustrated by the green line in Figure 3, where the test wall with the most exterior insulation remained above the dew point for almost the entire test period. Correspondingly, this test wall was free of visible mold after the two-year experiment.

Figure 3. Temperatures at the sheathing plane. The test wall with the most exterior insulation stayed above the dew point for both winters, successfully avoiding condensation on the sheathing.

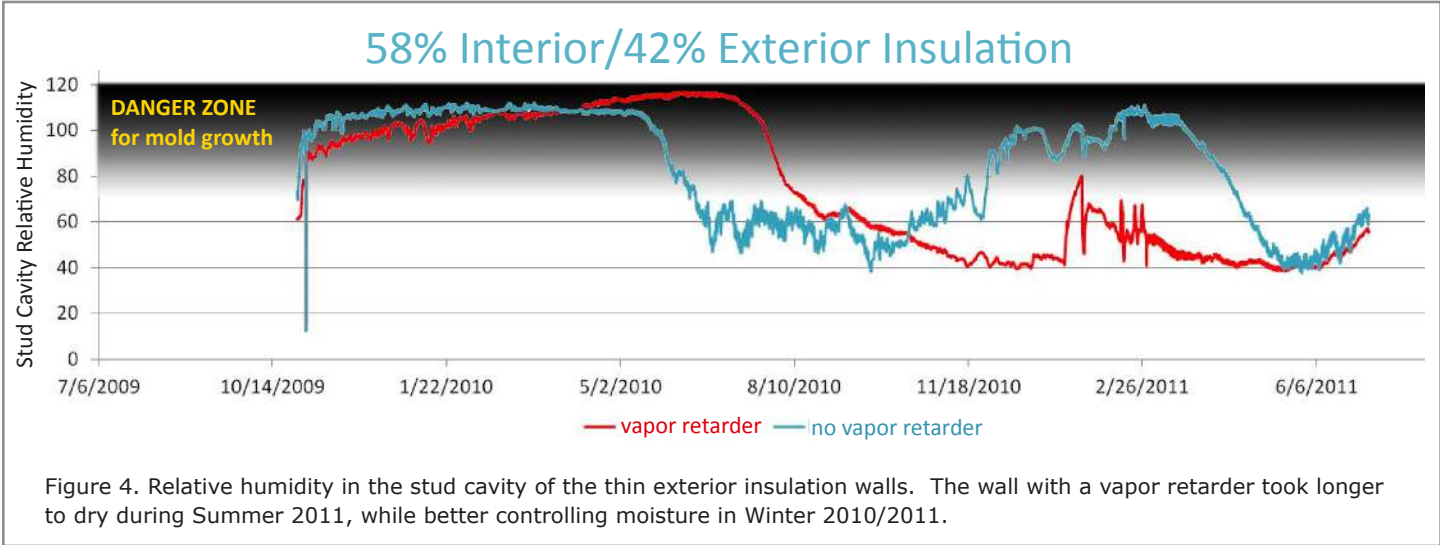
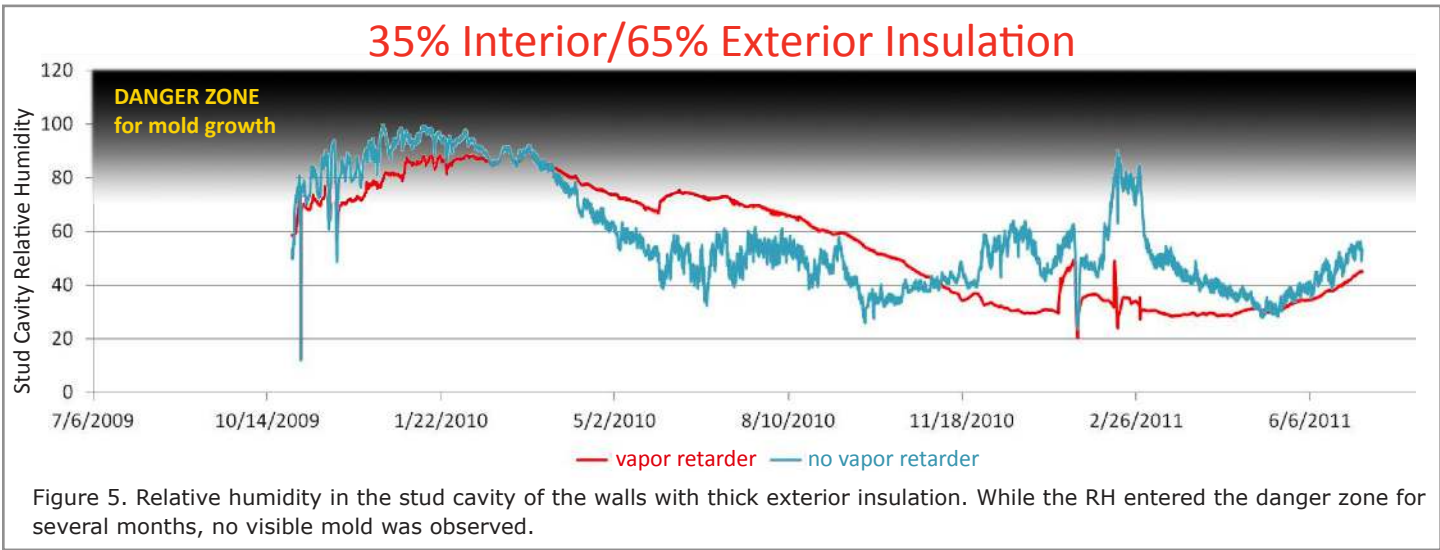
100% relative humidity in terms of potential for mold growth. The higher the humidity, the less time it takes for visible mold growth to become established (Viitanen, 1994). The walls with thin exterior insulation were essentially at 100% humidity all of the first winter, with or without a vapor barrier (Figure 4). In contrast, the walls with thick exterior insulation were able to stay under 100% relative humidity (Figure 5). The test wall with 65% exterior insulation and a vapor retarder was even able to remain under 90% relative humidity. Notable for both graphs is that the test walls with a vapor retarder took longer to dry during the summer than the test walls without a vapor retarder. This matches expectations, as walls without vapor retarders can dry more easily to the inside. However, this drying capability did not spare the test walls without vapor retarders from abundant mold growth on the sheathing.

During the second winter when humidity and pressure within the MTL were more representative of typical home conditions (25% RH and neutral pressure), the contribution of an interior vapor retarder was more apparent. Humidity was consistently higher for the test walls without vapor retarders. The test walls with a vapor retarder stayed safely under 80% relative humidity at the sheathing, as long as 42% or more of the wall R-value was exterior to the sheathing. The test wall with 30% exterior insulation had high humidity at the sheathing plane (data not shown), and demonstrated the most widespread mold growth of all the test walls with a vapor retarder.
