CAROLINAS Roofing

November . December 2011
Vol. 2 / Issue 6

Prevent Leaks at Roof-wall Intersections

KICK-OUT FLASHINGS CAN ELIMINATE THE LEADING CAUSE OF CALLBACKS AND CONSTRUCTION DEFECTS

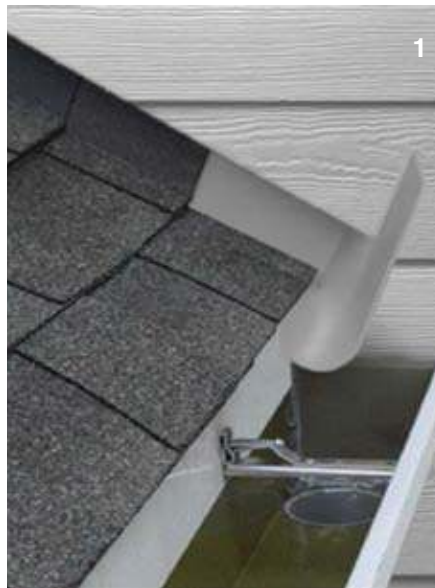
The intersecting building components in these areas act like a dam and most often direct water into wall assemblies. Gravity often causes this water to travel down the wall and cause damage at multiple locations. As a result, decay, mold and even deterioration of structural

members lead to callbacks, lawsuits and unhappy customers.

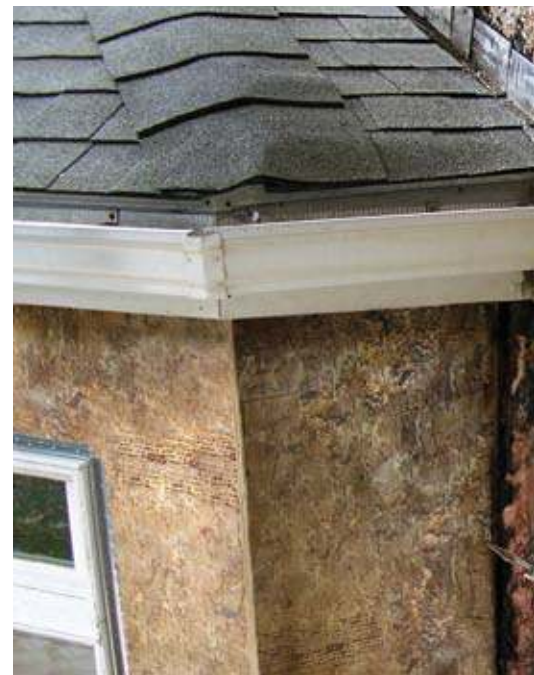
[1] This pre-molded, seamless, kick-out diverter flashing is manufactured by DryFlekt and is an excellent solution for reducing leaks at roof-wall intersections. (Learn more about this product on page 52.) [2] Water damage easily can occur at roof-wall intersections when flashing is neglected. [3] Metal kick-out diverter flashings often are poorly field-fabricated, which can lead to leaks. [4] The metal flashing is reverse-shingled over the brick, which can lead to leaks. [5] There is a gap between the step flashing and the water-resistive barrier because the barrier was improperly installed behind the step flashing. Water that gets behind the siding will run down the housewrap and penetrate between the step flashing and housewrap, leading to a ceiling leak.

Pre-molded, seamless, kick-out flashings, such as the one shown in Image 1, are an excellent solution for reducing leaks at roof-wall intersections. The polypropylene product works well in cold and warm climates, can be used with any roof slope and costs about \$11.

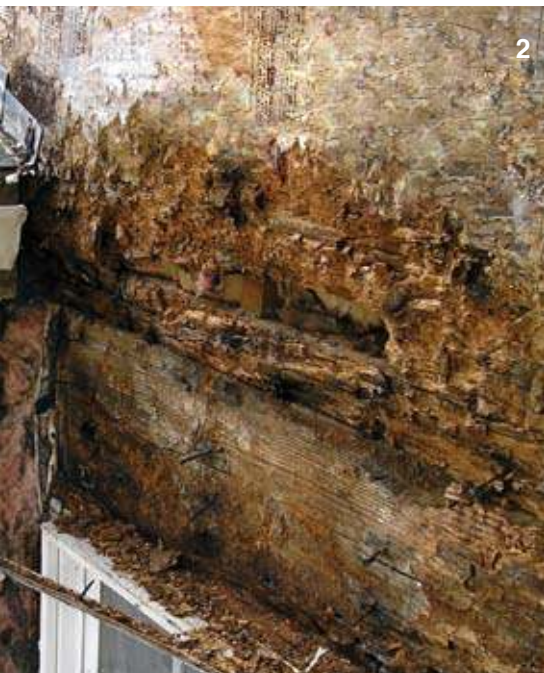
Image 2 shows what happens when kick-out diverter flashings are not used at roof-wall intersections. Water has penetrated behind the water-resistive barriers and the area did not dry before it got wet again, leading to rapid deterioration.

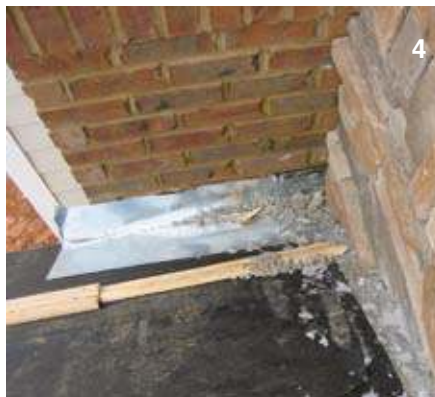
Metal kick-out diverter flashings often are poorly field-fabricated, which can lead to leaks as shown in Image 3.

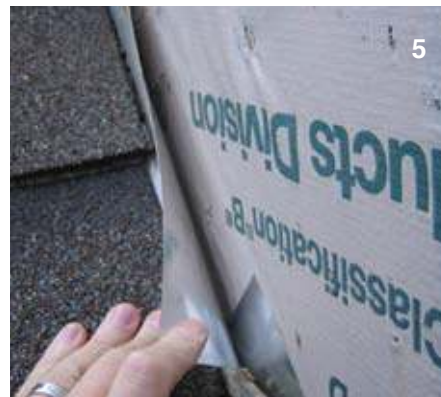
flashing design, which can lead to reverse shingling. For example, Image 4 shows a horizontal valley where the roof meets the wall. The metal flashing is reverse-shingled over the brick. Proper inspection would have avoided this situation.

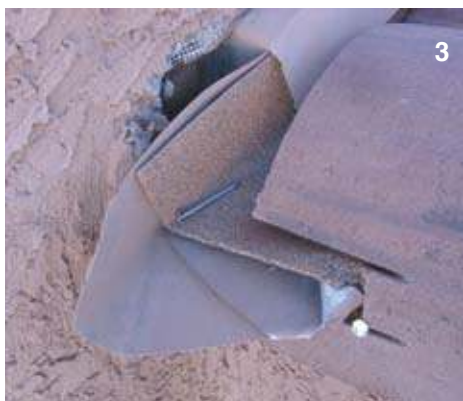
There is a gap between the step flashing and the water-resistive barrier in Image 5 because the barrier was improperly installed behind the step flashing. Any water that gets behind the siding will run down the housewrap and penetrate between the step flashing and housewrap, leading to a ceiling leak.

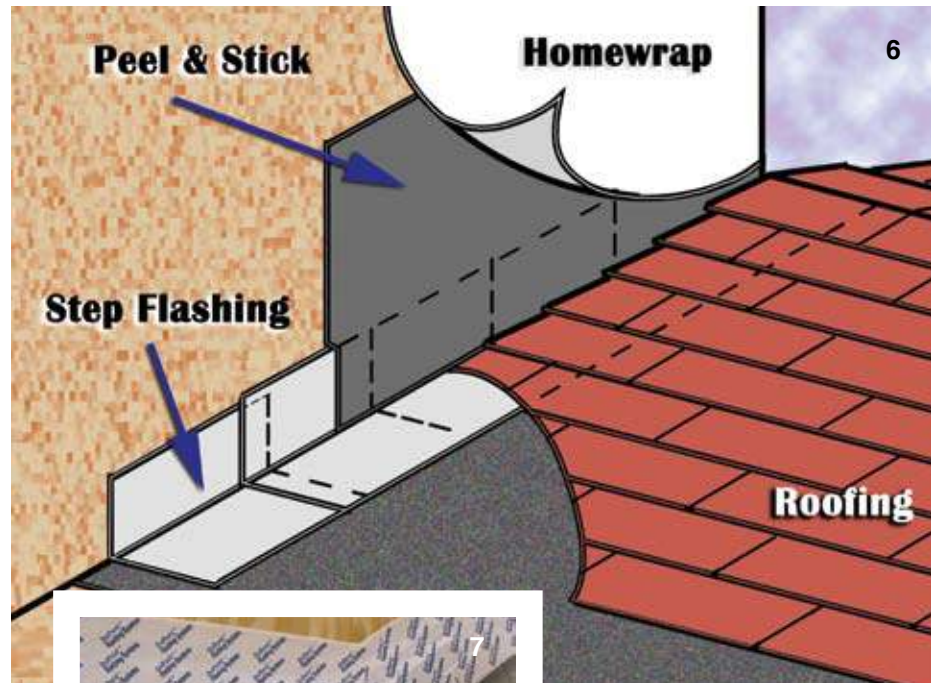
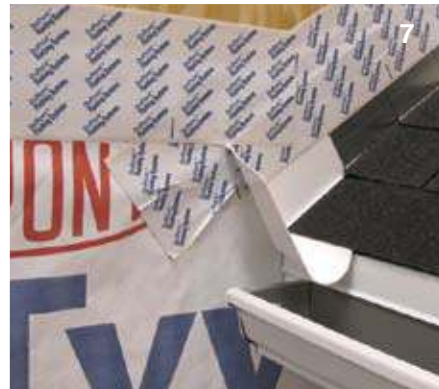
[6 and 7]

This is a properly integrated kick-out diverter flashing with peel-and-stick flashing and housewrap.

In Image 6, a peel-and-stick flashing seals over the metal step flashing onto the sheathing. If any water gets behind the housewrap, it will run onto the peel-and-stick flashing to daylight. Image 7 illustrates a real-world, properly integrated kick-out diverter flashing with peel-and-stick flashing and housewrap.
