COLD CLIMATE HOUSING RESEARCH CENTER

# Evaluating the Need for Vapor Retarders with Open Cell Polyurethane and Cellulose Insulation in Extreme Cold Climates

February 3, 2014

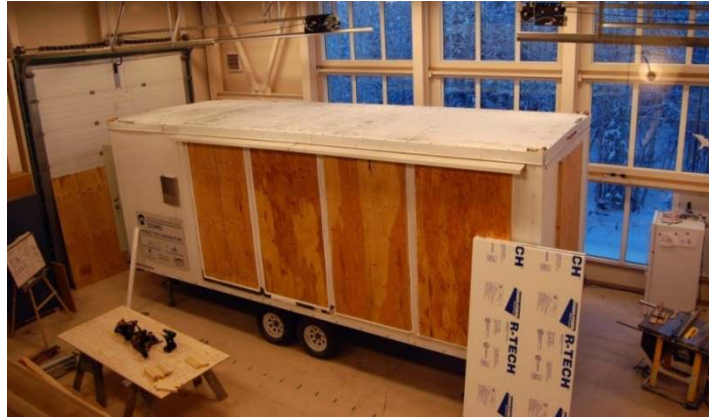
Figure 1. The MTL under construction. The walls for the MTL were constructed inside the building and then the trailer was moved outside to a clearing to the south of the building.

above the neutral pressure plane or unbalanced mechanical systems. Figure 1 shows the exterior of the MTL under construction. The test wall configurations are labeled with numbers as shown in Figure 2.

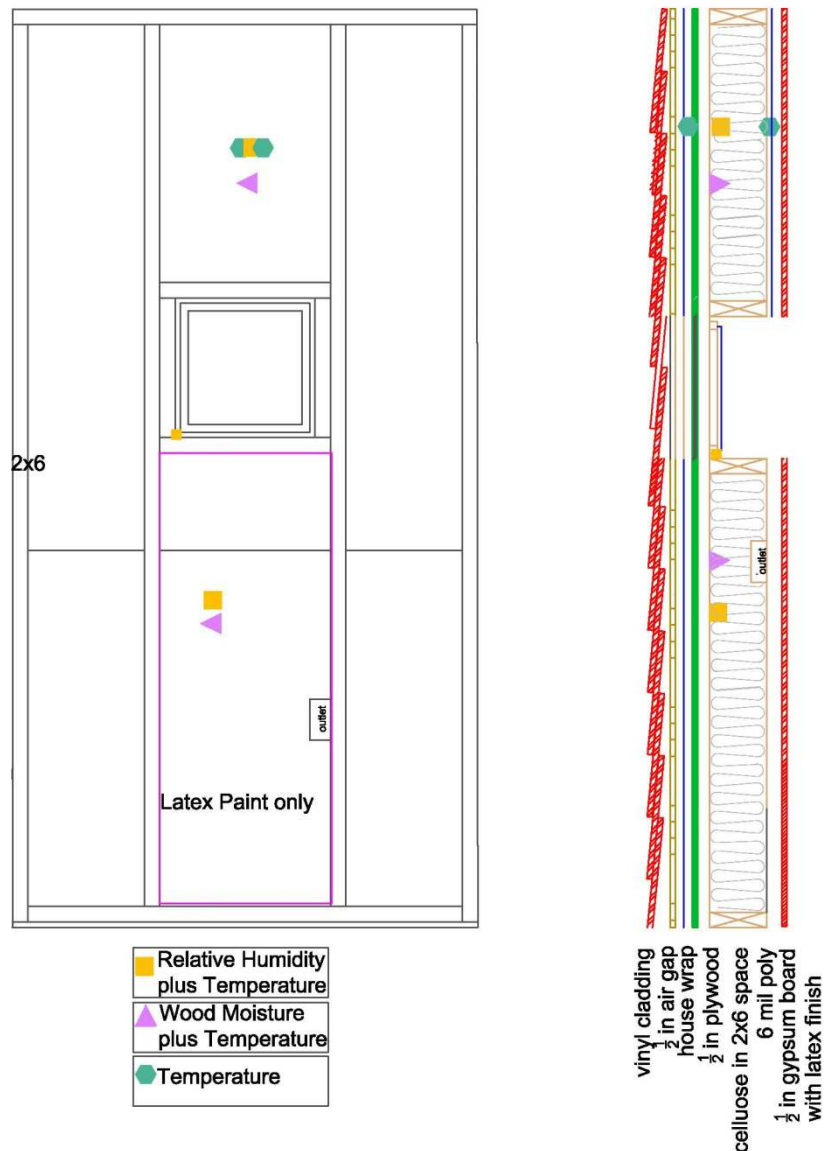
Figure 7. The cellulose wall. All of the wall but the space below the window had a 6 mil vapor retarder.

Wall 3 was sheathed with ½-inch plywood and insulated with dense-pack cellulose covered with a six-mil polyethylene vapor retarder (an ICC class I vapor retarder) sealed at the test wall perimeter (plates and studs) with acoustical sealant. The stud bay below the window only had latex paint (ICC class III) as its vapor retarder. The penetration for the window was adhered to the face of the window buck studs with staples, and the annular space between the window and the framing was filled with one-component spray foam. The penetration for the electrical outlet was not sealed. The gypsum board on the interior face received one coat of primer and one coat of latex paint as a finish.

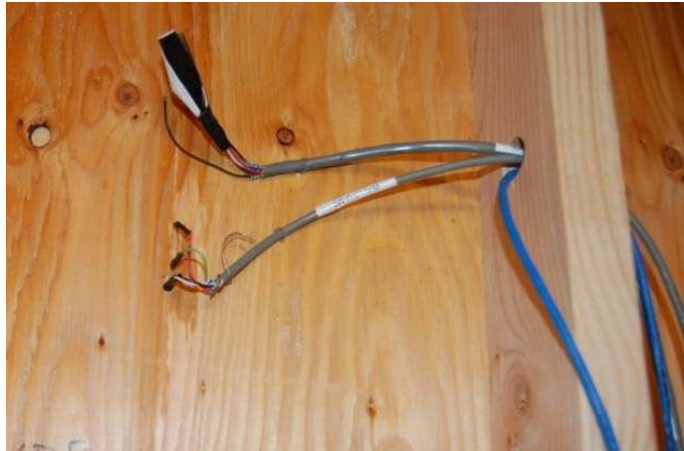
Figure 8. Sensors installed on the plywood sheathing. The relative humidity/temperature sensor is on the top. Below it the moisture content sensor is embedded directly into the plywood.

The moisture content resistance pins are small brass rods soldered to the end of wires. The two rods were embedded in plywood sheathing, 1 inch apart, to the same depth. A thermistor was also embedded in the plywood near the pins. The two pins along with a 3 Mohm resistor formed a bridge circuit. The resistance of the wood between the pins was recorded and translated into moisture content using equations 1 and 2. The sensors were attached to the interior face of the plywood sheathing (Figure 8).

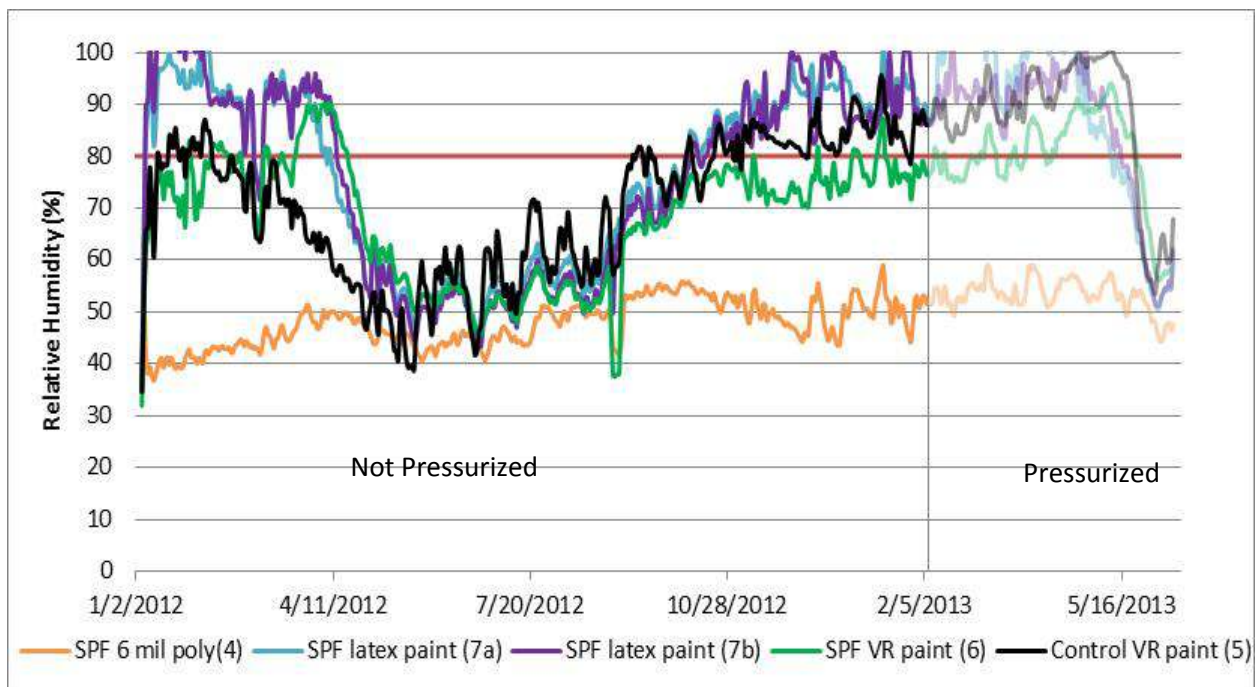
**Figure 11. Relative humidity in the outlet cavity of the ocSPF walls. Walls with strong vapor retarders had humidity values below the 80% threshold for mold (the red line) for a majority of the study. Wall numbers are in parentheses.**

Walls 6 and 5 both had low perm paint as their vapor control layer; low perm paint is considered a class II vapor retarder. There was more moisture infiltration into the stud cavity with the low perm paint than the class I 6 mil polyethylene. The ocSPF wall fared better than the fiberglass wall hovering around 80% relative humidity even when pressurized (Figure 11). This difference may be due to the air tightness qualities of the ocSPF.

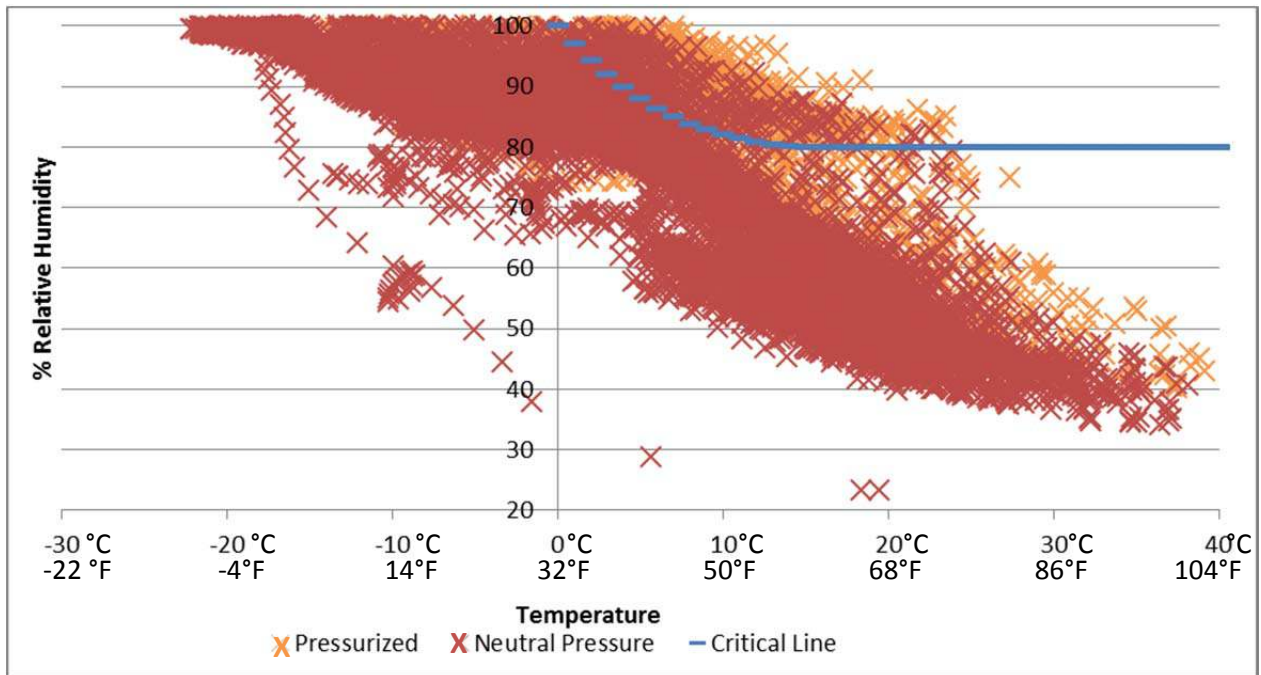
Figure 13. A plot assessing the mold growth potential on the plywood sheathing of the outlet stud cavity of Wall 7b. This wall had ocSPF insulation and latex paint as its vapor retarder, however a majority of the high humidity happened when the temperature was too low for mold growth. This test wall had one spot of visible mold at the sheathing.

A plot of relative humidity versus temperature can provide a better estimate of whether a wall is in danger of mold growth (Figure 13). When a certain number of hours (usually more than 2 weeks) are spent above the critical relative humidity/temperature function, the wall is in danger of growing mold. The critical function comes from equation 4 for critical mold conditions developed by Hukka and Viitanen (1999).

Each data point (represented by x) in the chart represents 1 hour. In addition to critical temperature and relative humidity, a certain amount of continuous time at the critical conditions is required to initiate mold growth. The plots do not necessarily show continuous time above the critical line; the points above the line might have been spread over the course of the 17-month study.

The plots provide more insight into the difference between the unpressurized and pressurized walls. There are fewer data points for the pressurized data, but the humidity is higher in those three months.

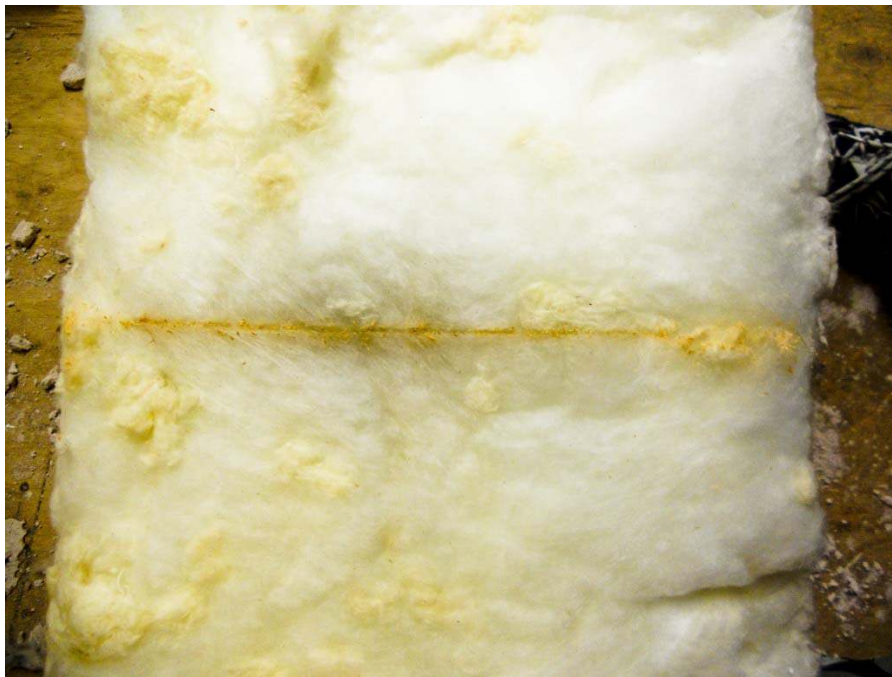
Figure 17. Back of fiberglass from Wall 5. The line in the fiberglass is from the cut that was made in the plywood during construction. The grey discoloration around the line is most likely due to air leakage around the gap in the plywood. Photo courtesy of Randy Nicklas of Icynene.

dramatically with the pressurization of the lab (Figure 16). Figure 17 shows the discoloration on the back of the fiberglass at the split in the plywood, another indication of air leakage through the fiberglass.

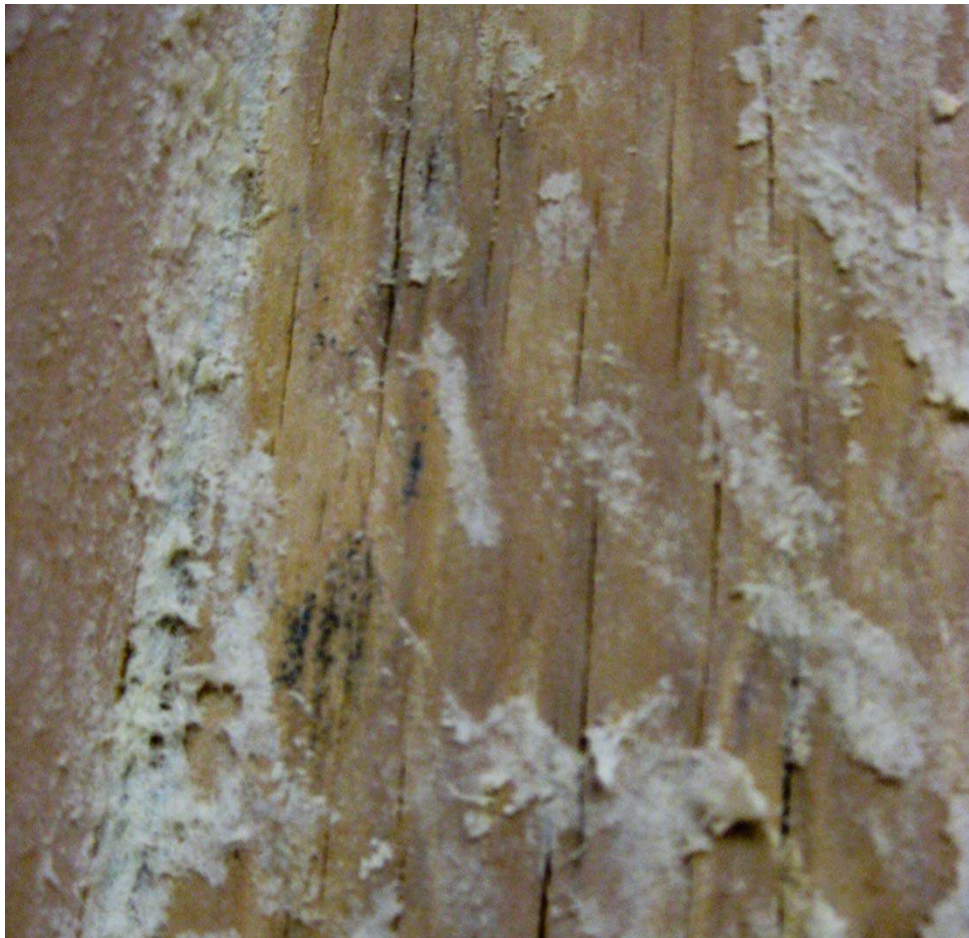
**Figure 18.** Mold in the upper cavity of Wall 7b. The spot of mold is less than 1 in<sup>2</sup>.

These test results indicate that some level of vapor retarder is required when using ocSPF as insulation for walls in extreme cold climates. The 6 mil polyethylene and the smart vapor retarder both provided adequate vapor control for the ocSPF walls. The low perm paint did not perform as well as the vapor retarders, but did slightly better than the wall with latex paint. The wall with latex paint had high relative humidity levels through most of the winter, and at least one spot of black mold growing on the plywood sheathing (Figure 18).

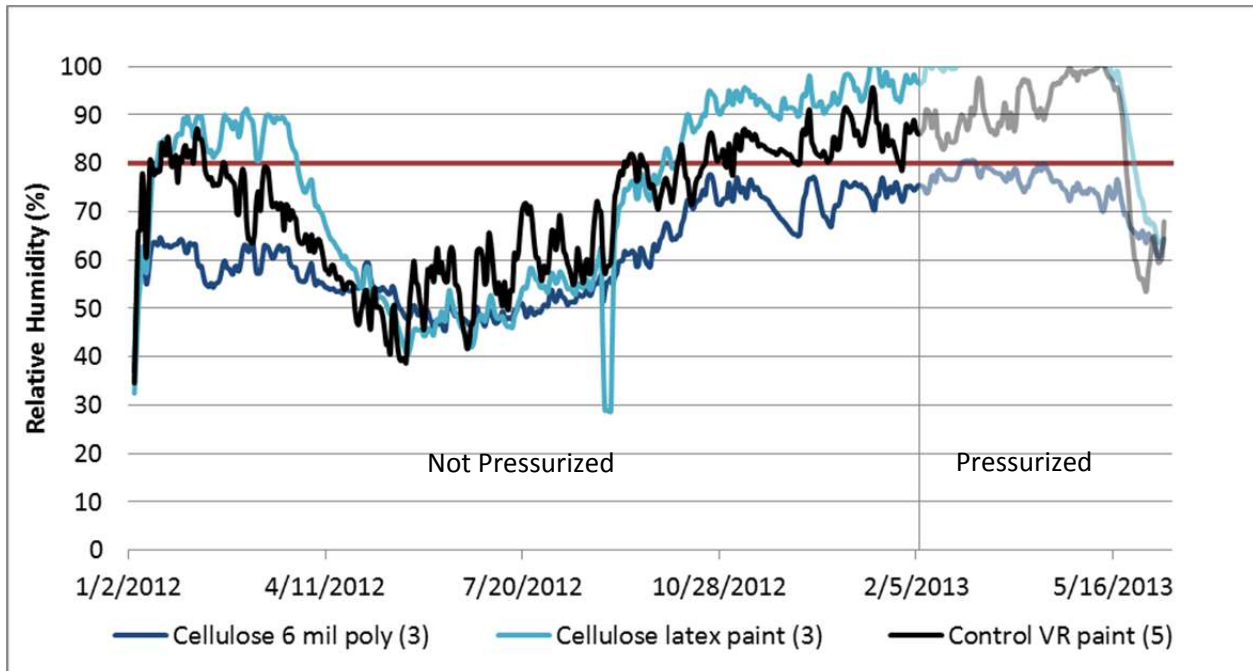
Figure 21. The relative humidity of the cellulose wall. Cellulose with a strong vapor retarder performed slightly better than the fiberglass wall with the low perm paint. The red line is the 80% relative humidity line of concern. Wall numbers are in parentheses.

The relative humidity in the cellulose wall at the sheathing plane followed a similar pattern as the moisture content. The wall with a strong vapor retarder performed well, with the humidity staying below the 80% threshold. The wall with only latex paint had higher relative humidity, especially during the end of the study when the MTL was pressurized.

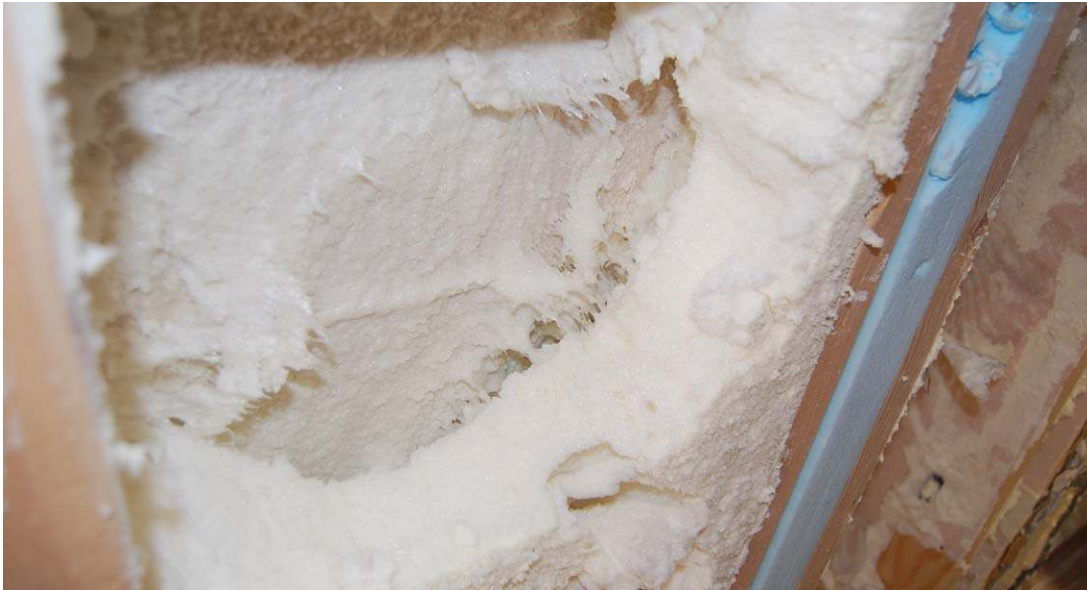
**Figure 24. Voids in the ocSPF of Wall 7a. Instead of adhering to the plywood, the ocSPF created an air pocket throughout the lower cavity of Wall 7a. This photo shows the full span of the 15-inch stud cavity.**

The in-situ R-value analysis of the test walls found large variation in the wall R-values. The variations are hard to specify and are likely due to a variety of factors. For example there were voids found in some of the ocSPF walls when they were taken apart, resulting from less-than-perfect spraying conditions (Figure 24). The walls were sprayed inside; however the spraying equipment was in a truck outside in late December when the ambient temperature was around 4°F. The spray foam contractor had problems with faulty drum heaters. There were problems keeping the lines and the barrels at the correct temperature, which may have contributed to the voids. Another source of variation in the in-situ R-values is the air movement inside the MTL which introduced convective heat transfer that the sensors cannot read. In aggregate, these factors lead to the in-situ R-values being provisional data.

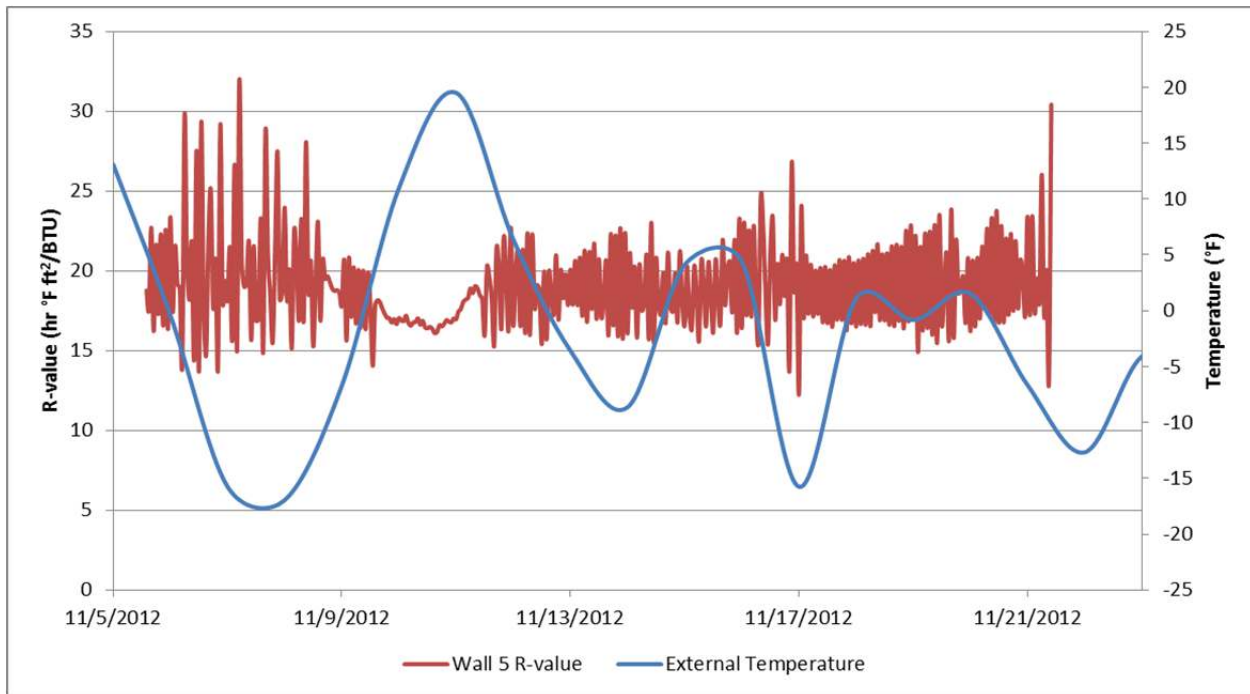
Figure 25. Early in-situ R-value data. Later data were less noisy with the logger better grounded.

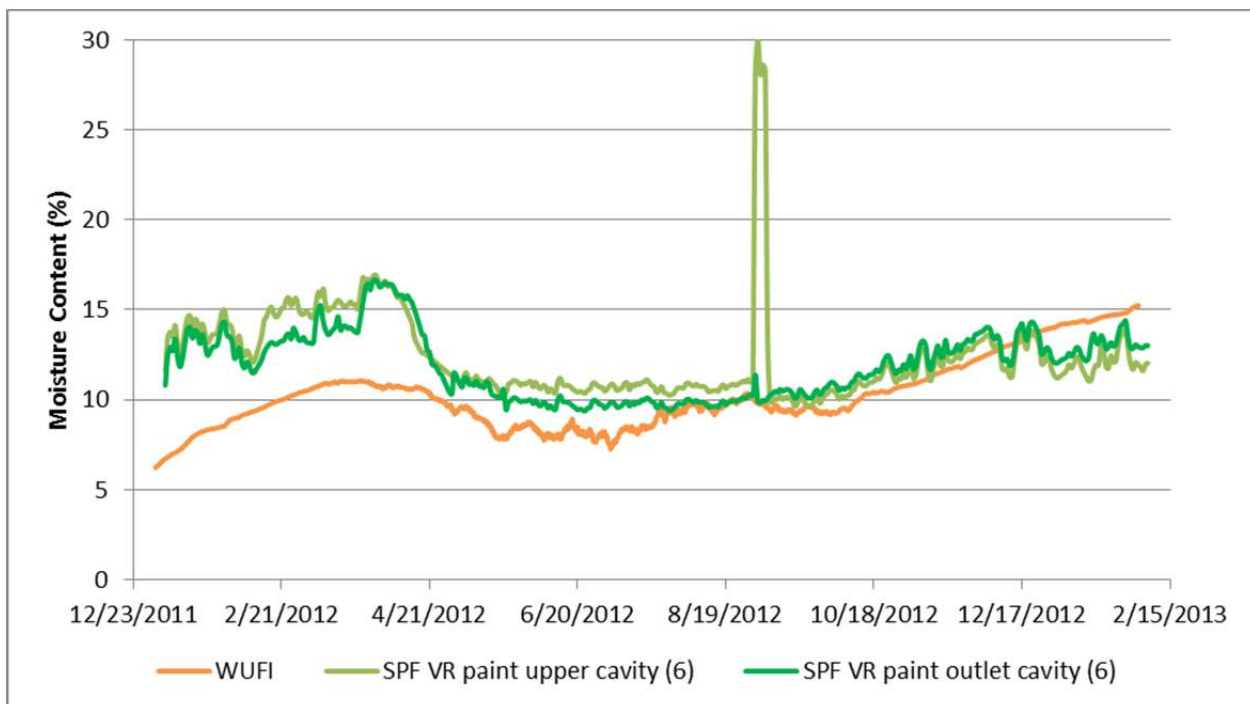
Figure 30. Comparison of WUFI sheathing moisture content to the MTL Wall 6. The green spike is likely an error in the data collection system. Wall numbers are in parentheses.

In terms of moisture content, the WUFI model predicted lower moisture content than was measured in the MTL walls with a class II vapor retarder (Figure 30). Some of this can be explained by the fact that

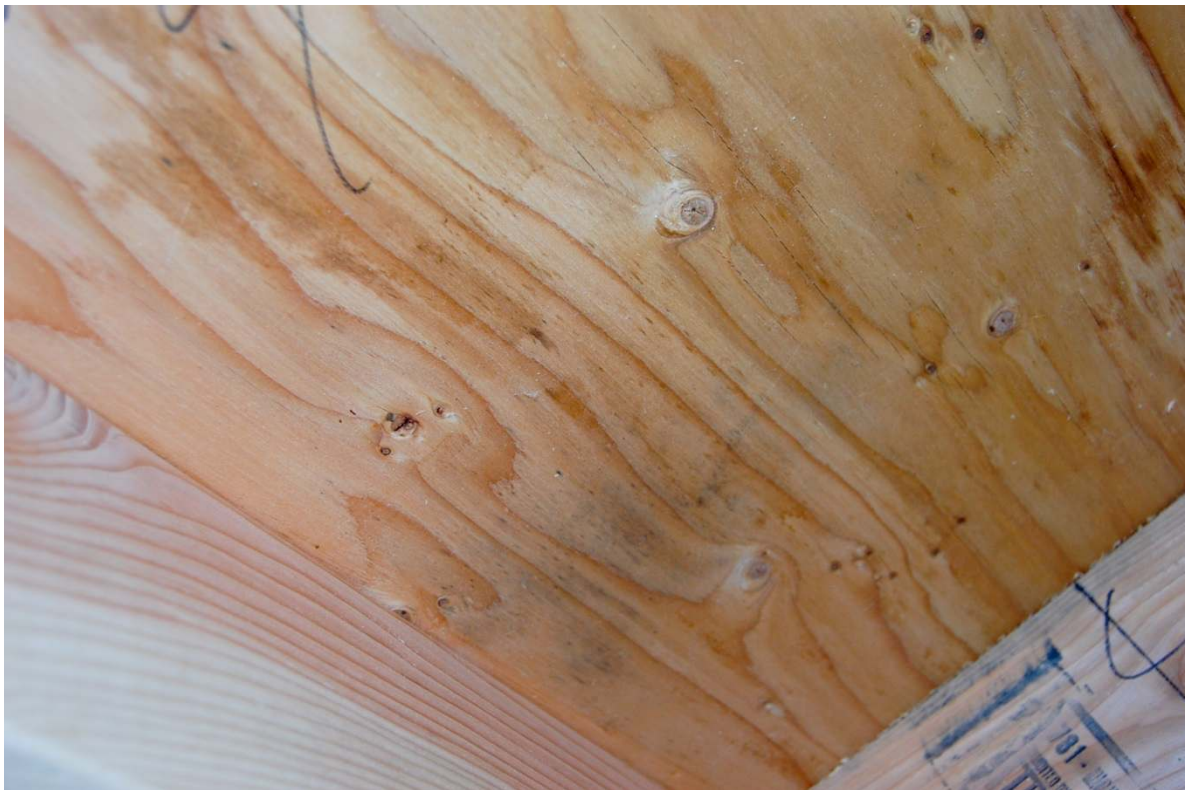
**Figure 34. Mold behind the fiberglass of Wall 5. This wall had a several spots of mold on the sheathing that WUFI Bio does not predict.**

problems. Table 4 presents some of the results of the 10 year model for the MTL walls. A rating of green means the wall does not have the conditions that allow mold to develop at the sheathing. Yellow is a cautionary color, meaning that there are sometimes conditions for mold but in these cases only in the worst conditions (i.e. the optimal culture medium, combined with high initial spore moisture content). The WUFI Bio-output does not completely agree with the MTL teardown data. Wall 5, in particular had several spots of mold on the sheathing when it was taken apart (Figure 34) and Wall 7 only had one small spot of mold (Figure 18). WUFI Bio did not predict the growth of mold in Wall 5 over the 10 year model, yet the test wall developed mold within its first year and a half.

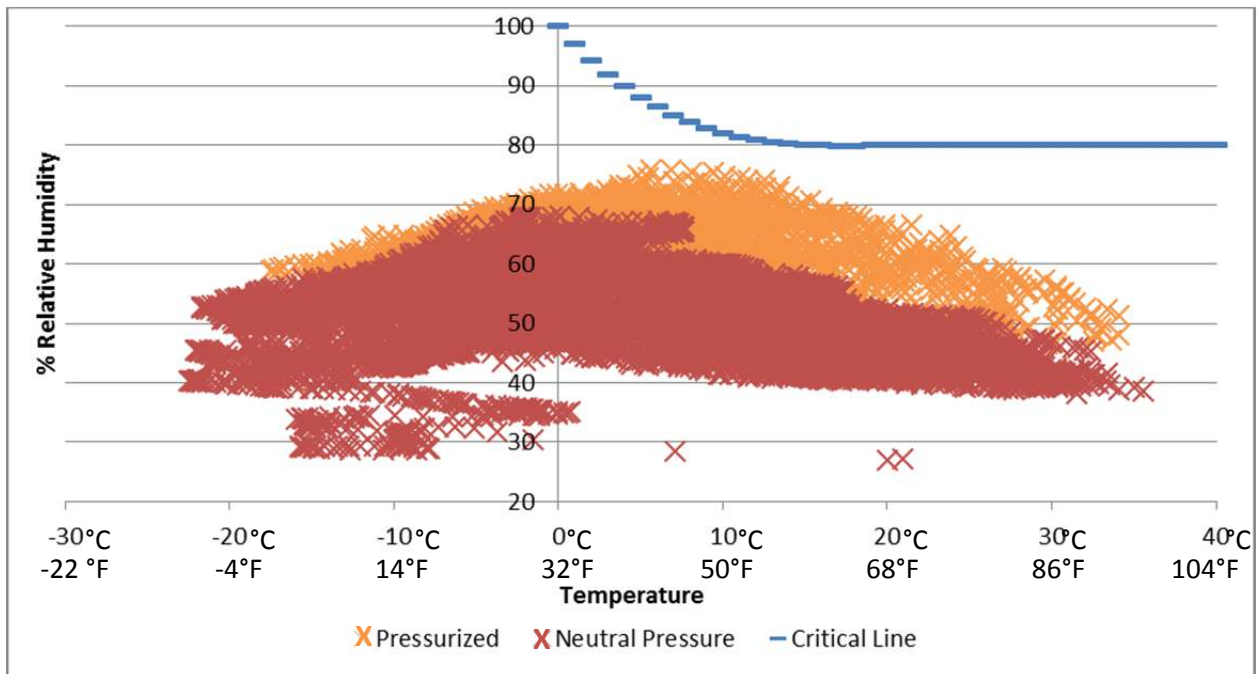
Wall 2 lower cavity, ocSPF with a smart vapor retarder

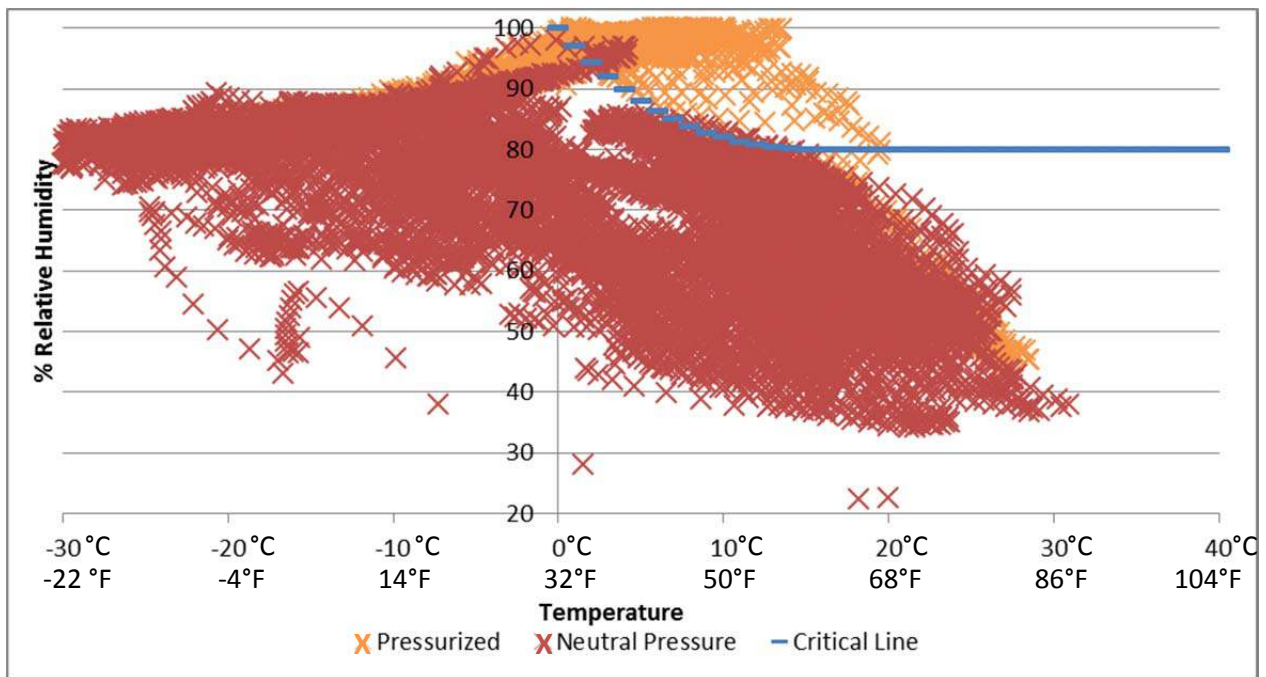
Wall 5 lower cavity, fiberglass with low perm paint
