Safe and Effective Exterior Insulation Retrofits: Phase II

by Colin Craven and Robbin Garber-Slaght
January 15, 2012

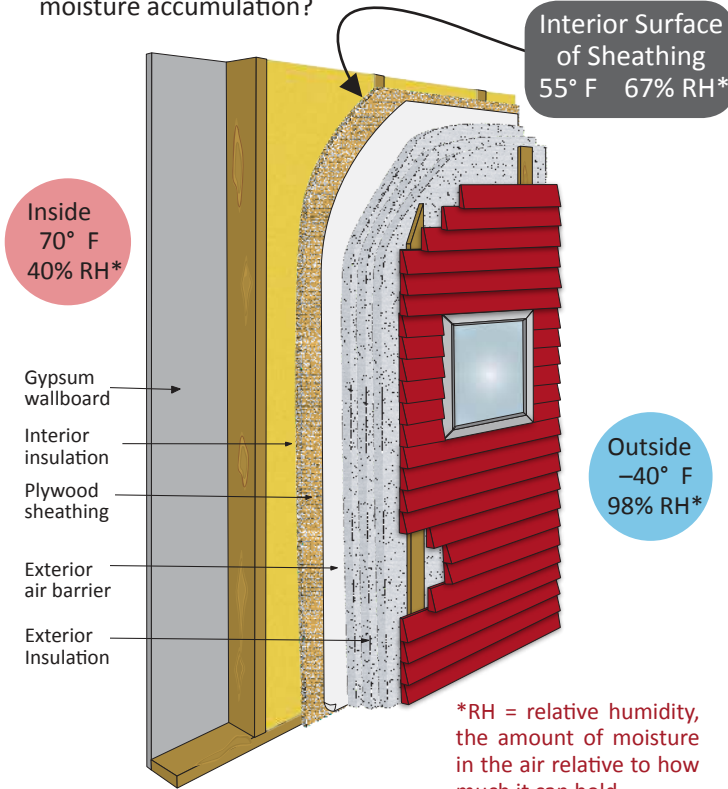
Figure 1. A general depiction of the wall system used in this study (not to scale). Variables across the nine wall sections include the presence or absence of an interior vapor retarder, 2x4 or 2x6 stud construction, and the amount of interior and exterior insulation. Note that interior insulation is placed in the stud cavities and exterior insulation is between the structural sheathing and the siding.
