## Building America Case Study Efficient Solutions for New Homes

# Attention to Details in High-Performance Homes

Leland, North Carolina

## North Carolina Builder Gets Serious About High-Performance

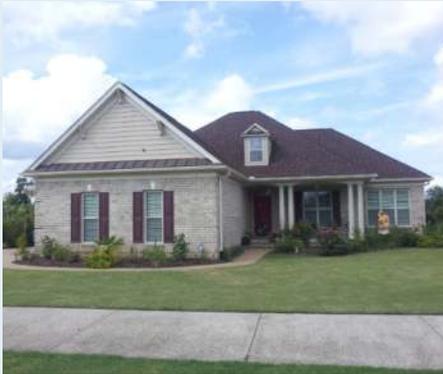
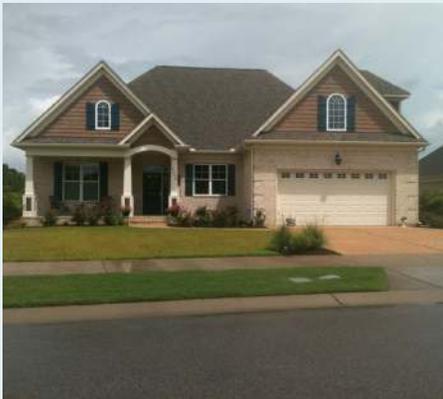
Below are pictures of neighboring homes. The upper has standard features (HERS 86), the home in bottom photo has high-performance options (HERS 56).

Heritage	Neighbor
HERS	56	86
Size [ft <sup>2</sup> ]	2,396	2,780
Building Leakage [ACH50]	3.41	5.38
Duct leakage [CFM25 out]	46	157
Heat pump	16 SEER/9 HSPF	13 SEER/7.7 HSPF
Water heater	Tankless propane (0.82 EF)	50 gallon electric (0.9 EF)
Attic insulation	R-38 w/ radiant barrier	R-30
Wall insulation	R-15	R-13
Ventilation	Balanced	None
Windows	Low-E 0.32/0.33	Low-E 0.35/0.35

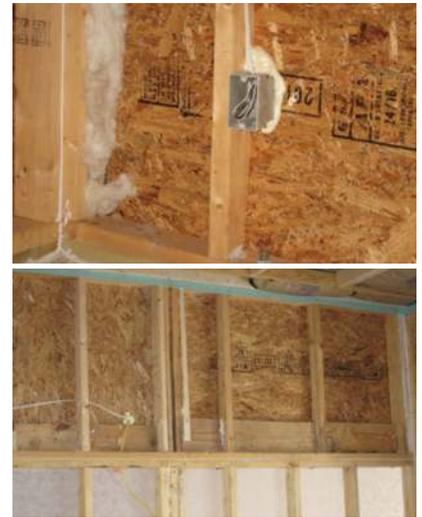
Many high performance improvements require attention to detail rather than a large investment. Electrical and plumbing holes were carefully sealed. Sill plate gasketing was used to seal sheetrock to the top plate. This is one of many low-cost improvements listed on the ENERGY STAR Thermal Bypass Checklist.

Many of the high-performance improvements did not come with significant additional costs, but did require more attention to detail. For example, following ENERGY STAR's Thermal Bypass Checklist. To make sure air sealing details were not overlooked in the field, Heritage builder Vic Sikka routinely returned to the construction site to personally seal any holes created by electrical and plumbing installations.
