Building America Efficient Solutions for Existing Homes

Case Study: Deep Energy Retrofit in the Pacific Northwest

Portland, Oregon

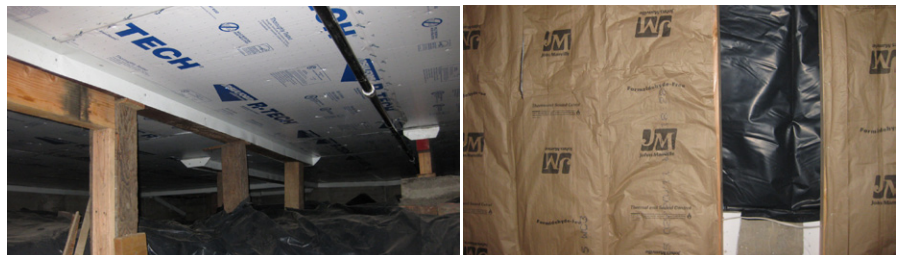
(left) In the crawlspace, R-30 fiberglass batts were installed between the 2x10 floor joists. The joists were then covered with 1 inch of expanded polystyrene (EPS) rigid foam board that was taped at the seams to provide a continuous air barrier and flashed at the edges to protect against rodents. The crawlspace floor was covered with a 6-mil visquene vapor barrier.

(right) On the lower 4 ft of the concrete basement walls 1" EPS was installed. Then a new 2-ft-high concrete stem wall was added in front of the rigid foam to support the aging existing foundation wall. The upper portion of the wall was covered with a plastic vapor barrier and framed with 2x4 studs; R-15 faced fiberglass batts were installed between the studs. Taped and mudded sheetrock provided a fire barrier, air barrier, and finished look to the basement wall assembly.

- Basement walls were lined with vapor barrier, framed with 2x4s, and insulated with R-15 faced fiberglass batts and/or rigid EPS.
- Crawlspace was insulated with R-30 fiberglass batts between floor joists and 1 inch of EPS rigid foam below joists, taped at the seams and rimmed with metal flashing.

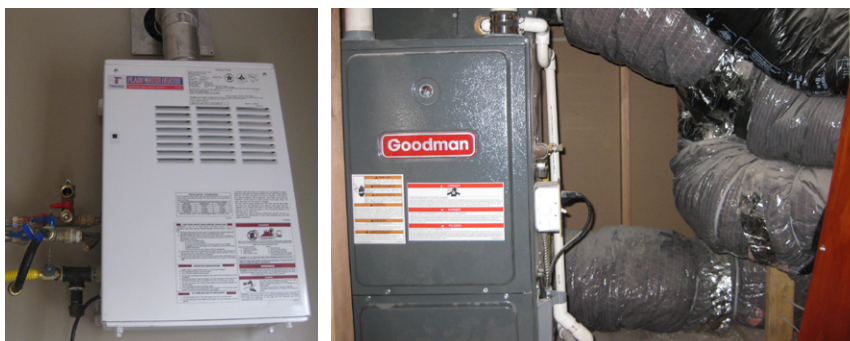
New high-efficiency heating and cooling equipment, water heater, and appliances lower energy consumption and improve indoor air quality.

(left) A 0.85 EF tankless hot water heater eliminates standby energy consumption.

- ENERGY STAR® refrigerator, dishwasher, and washer
- 0.85 EF natural gas tankless hot water heater
