Survey of Indoor Air Quality

University of Alaska Fairbanks Sustainable Village

by Martin Kotol
Visiting PhD student from the Danish Technical University

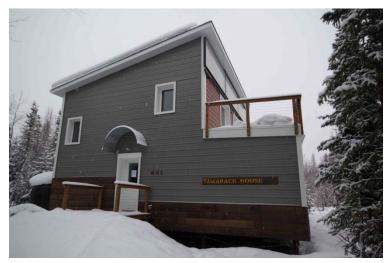
Figure 2. Tamarack house. This house has 5.5 inches (14 cm) of fiberglass batt in the stud space and 8 inches (20cm) of rigid polystyrene foam on the outside of the sheathing.

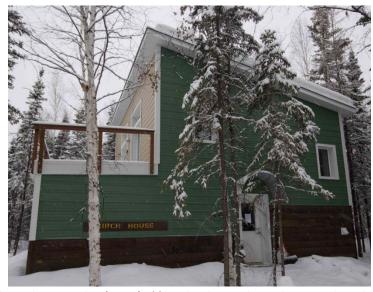
Figure 4. Birch house. This house has 5.5 inches (14 cm) of fiberglass batt in the stud space and 8 inches (20cm) of rigid polystyrene foam on the outside of the sheathing.

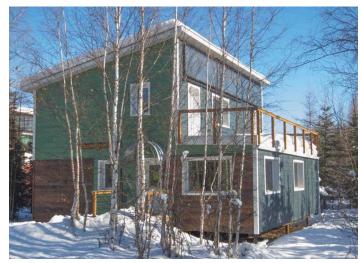
Figure 7. Willow house. This house has 5.5 inches (14 cm) of fiberglass batt in the stud space and 8 inches (20cm) of rigid polystyrene foam on the outside of the sheathing.

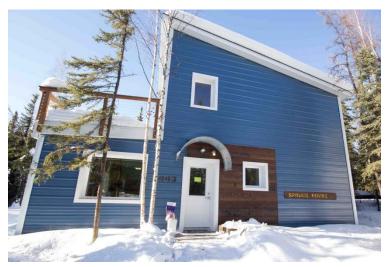
Figure 9. Spruce house. This house has 5.5 inches (14 cm) of fiberglass batt in the stud space and 12 inches (30.5 cm) of dense pack cellulose on the outside of the sheathing.
