Building America Case Study Technology Solutions for New & Existing Homes

Measure: Properly Sized and Located Return Air Inlets

Canyon Home Energy Retrofit

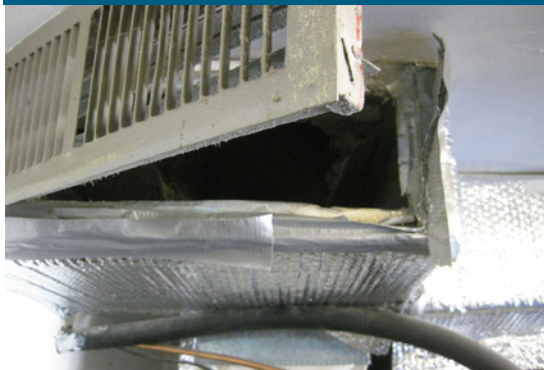
(bottom left) The small return air duct created a bottleneck in the air distribution system, limiting its ability to provide adequate conditioning. The use of building cavities also caused the duct system to be very leaky and inefficient. The new return duct system was not only properly sized for the target air flow rate, but was also insulated and sealed to prevent heat loss and infiltration.

Building America researchers recommended removing the garage return duct, adding a return on the lower floor, and sealing and insulating the ducts. This increased the return air flow through the handler from 660 cubic feet per minute (cfm) to 1,126 cfm, and dramatically improved homeowner comfort by allowing the conditioning systems to deliver considerably more conditioned air and enabling better air mixing between floors. By sealing the ducts, the duct leakage to outside was also decreased from 400 cfm at 25 pascals of depressurization (cfm₂₅) to 276 cfm₂₅, almost a 50% reduction.

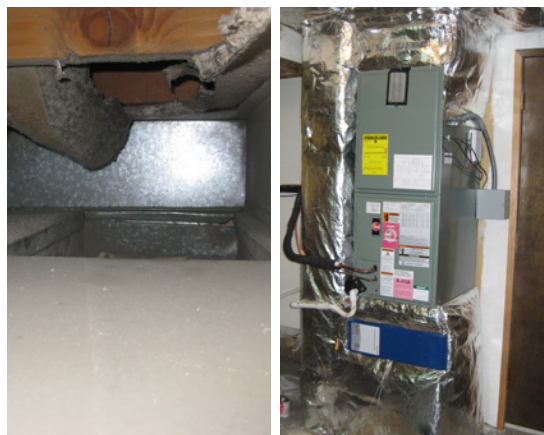
(bottom right) A new, high-efficiency (SEER 16/HSPF 9) heat pump was installed to replace the 30-year-old furnace and SEER 10 air conditioner when the ducts were being replaced.

More importantly, these measures avoided potential indoor air pollutants from the garage entering the living space. The original heating and cooling systems were replaced with a high-efficiency heat pump, further reducing the energy needed to condition the home.
